## **Investigation of Hydrophobic Concrete Additive for Seawall Replacement at Pililaau Army Recreation Center, Hawaii**

Final Report on Project F09-AR05A

May 2017

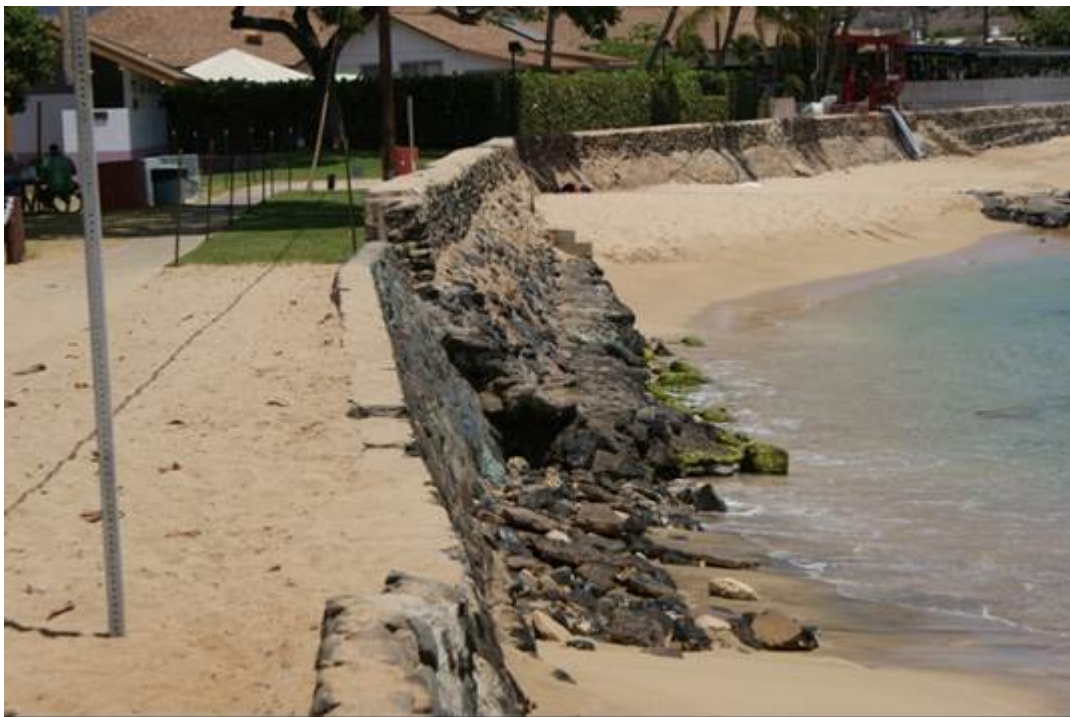
Figure 2. Section of deteriorated seawall.

As noted in Chapter 1, the PARC seawall dates from about 1950 and includes major rehabilitations performed in 1983 and 1993. The existing reach of seawall that is north of the 1993 repair was part of the 1983 rehabilitation project. This reach has sections that are cracked and undermined, and are in need repair or replacement (Figure 2).

An onsite inspection was performed by the Engineer Research and Development Center-Construction Engineering Research Laboratory (ERDC-CERL), the Hawaii Garrison DPW, and contractors. The team surveyed the seawall to plan and program the execution of the project. Given the

The design selected and approved by ERDC-CERL and the garrison's DPW was a concrete veneer structure to repair an existing section of seawall. The veneer was designed to include precast panels with the front molded to resemble the rock pattern of the adjacent wall. The panels would be secured to the existing seawall and placed on a concrete footer at the base of the seawall. Treated concrete then would be poured between the precast panels and the seawall and over the top of the existing seawall to create a reinforced concrete cap (Figure 3).
